TRUE STORIES 1

Juicing machine – Finger Amputation

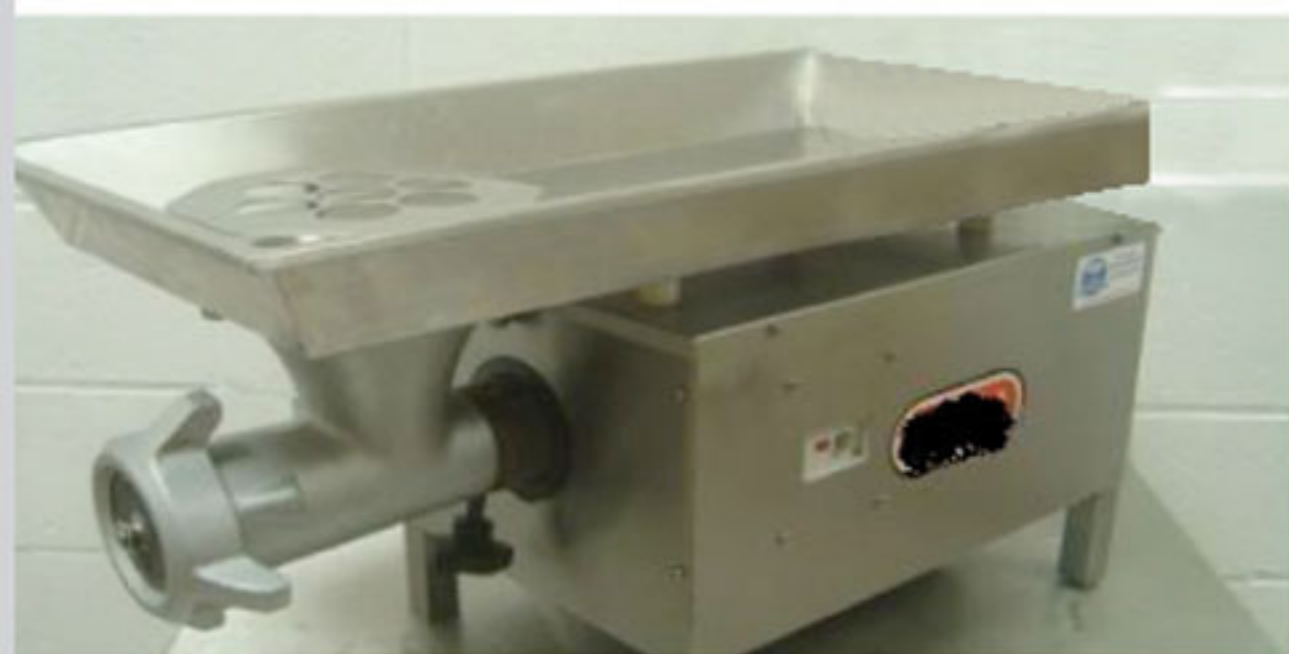
Note: This opening into this mincer is guarded to prevent access to the danger zone.

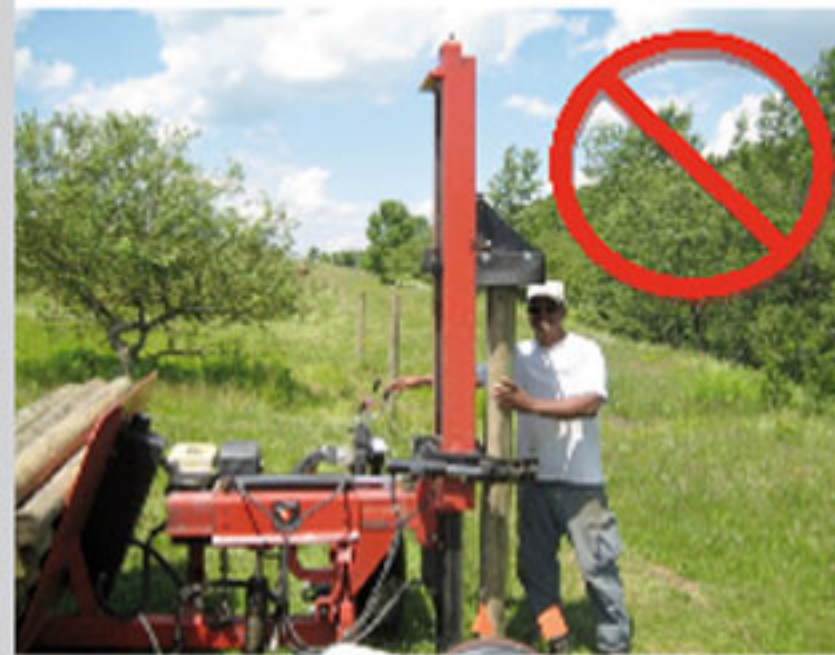
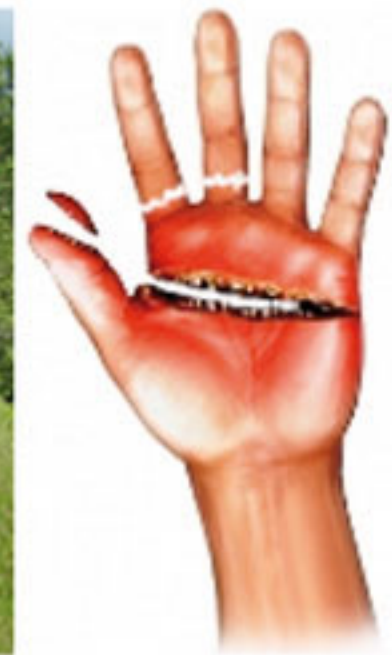
An example of a post driver without protective guards.

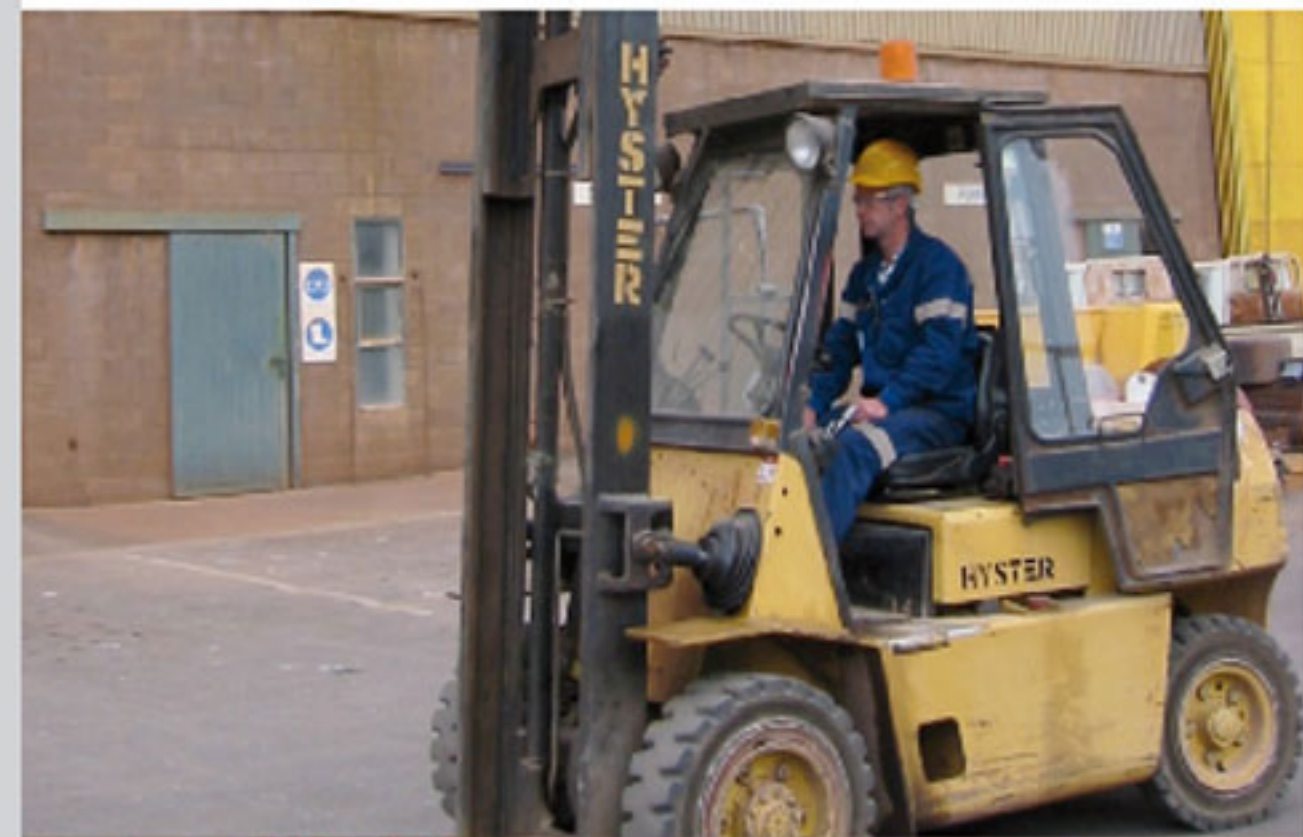
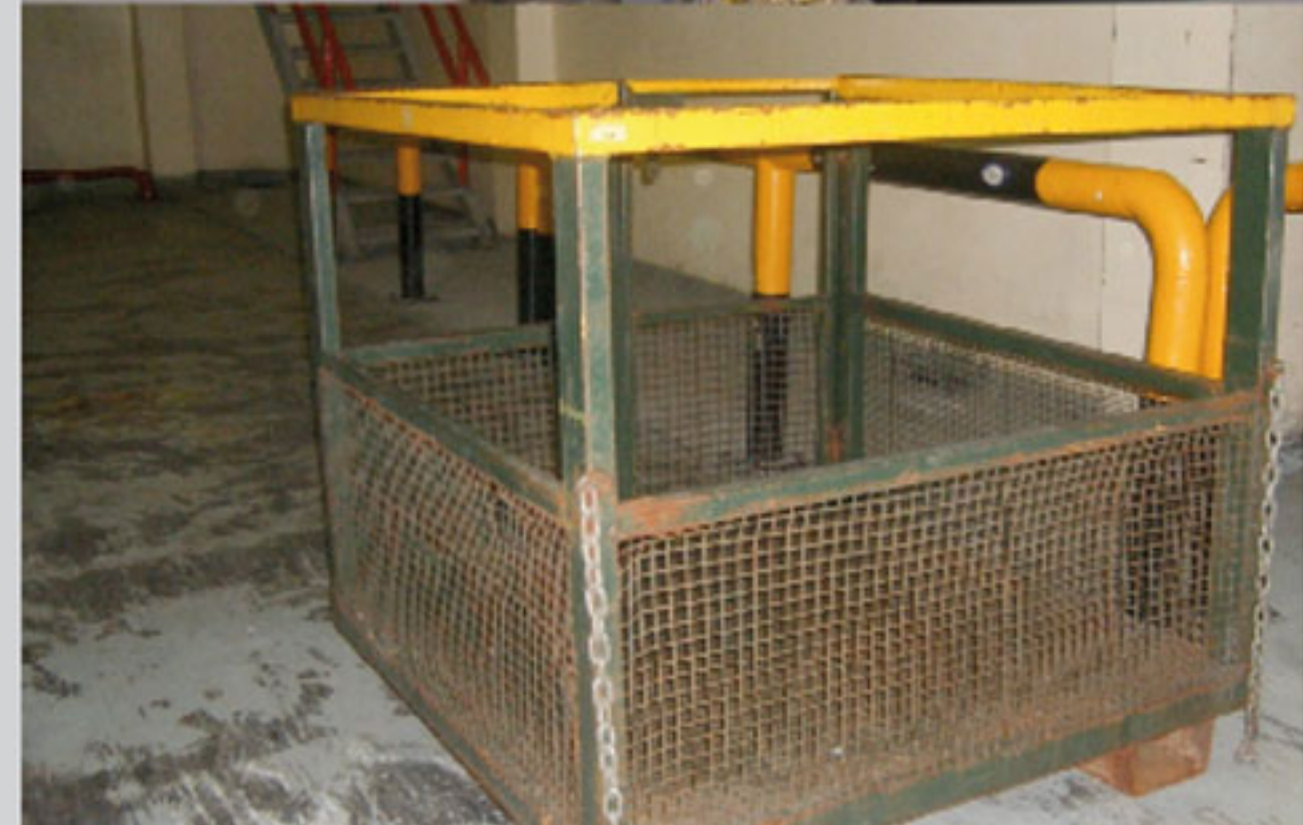
A basket not secured to the forklift forks was used to raise the Fitter to secure a pipe to the factory wall. The basket overturned on the forks when his weight shifted and he fell to the ground.

Basket was withdrawn from service as it was not secured to the forks and have controls directly linked to the forklift.

Mobile Elevating Working Platform now hired for all such work at height.

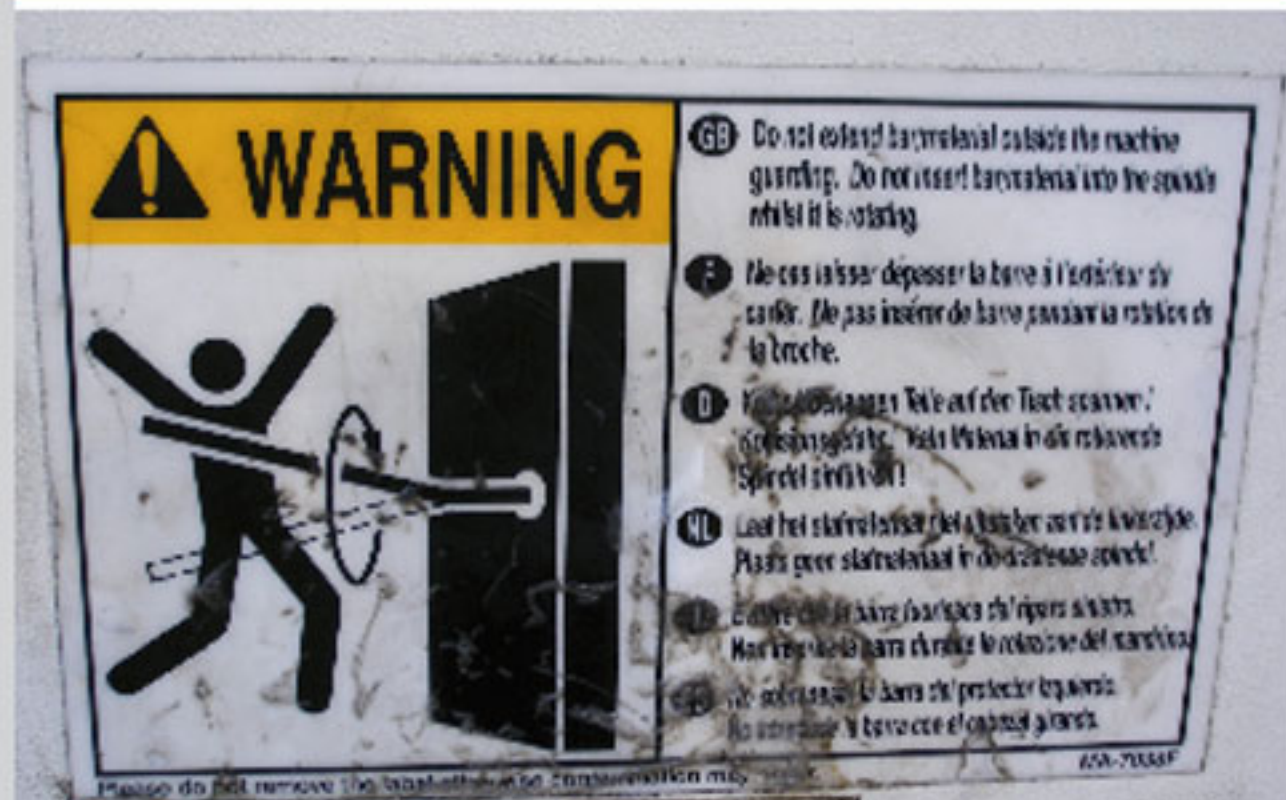
The bar for turning was too long for machine it was therefore put through the port in the back of the machine extending outside the machine's guarding. Back stop to prevent work piece loosening was not in place. The lathe was running at 1800 rpm,s. The bar came free and hit passing operator.

Note: Warning label on machine describes exactly what happened.

Retraining for operators and port sealed up. Procedure awareness reinforced. Zone around machine highlighting danger area.
